# **OTAY RIVER RESTORATION PROJECT FINAL HABITAT MITIGATION AND MONITORING PLAN (HMMP)**

**September 2015, Revised March 2016**

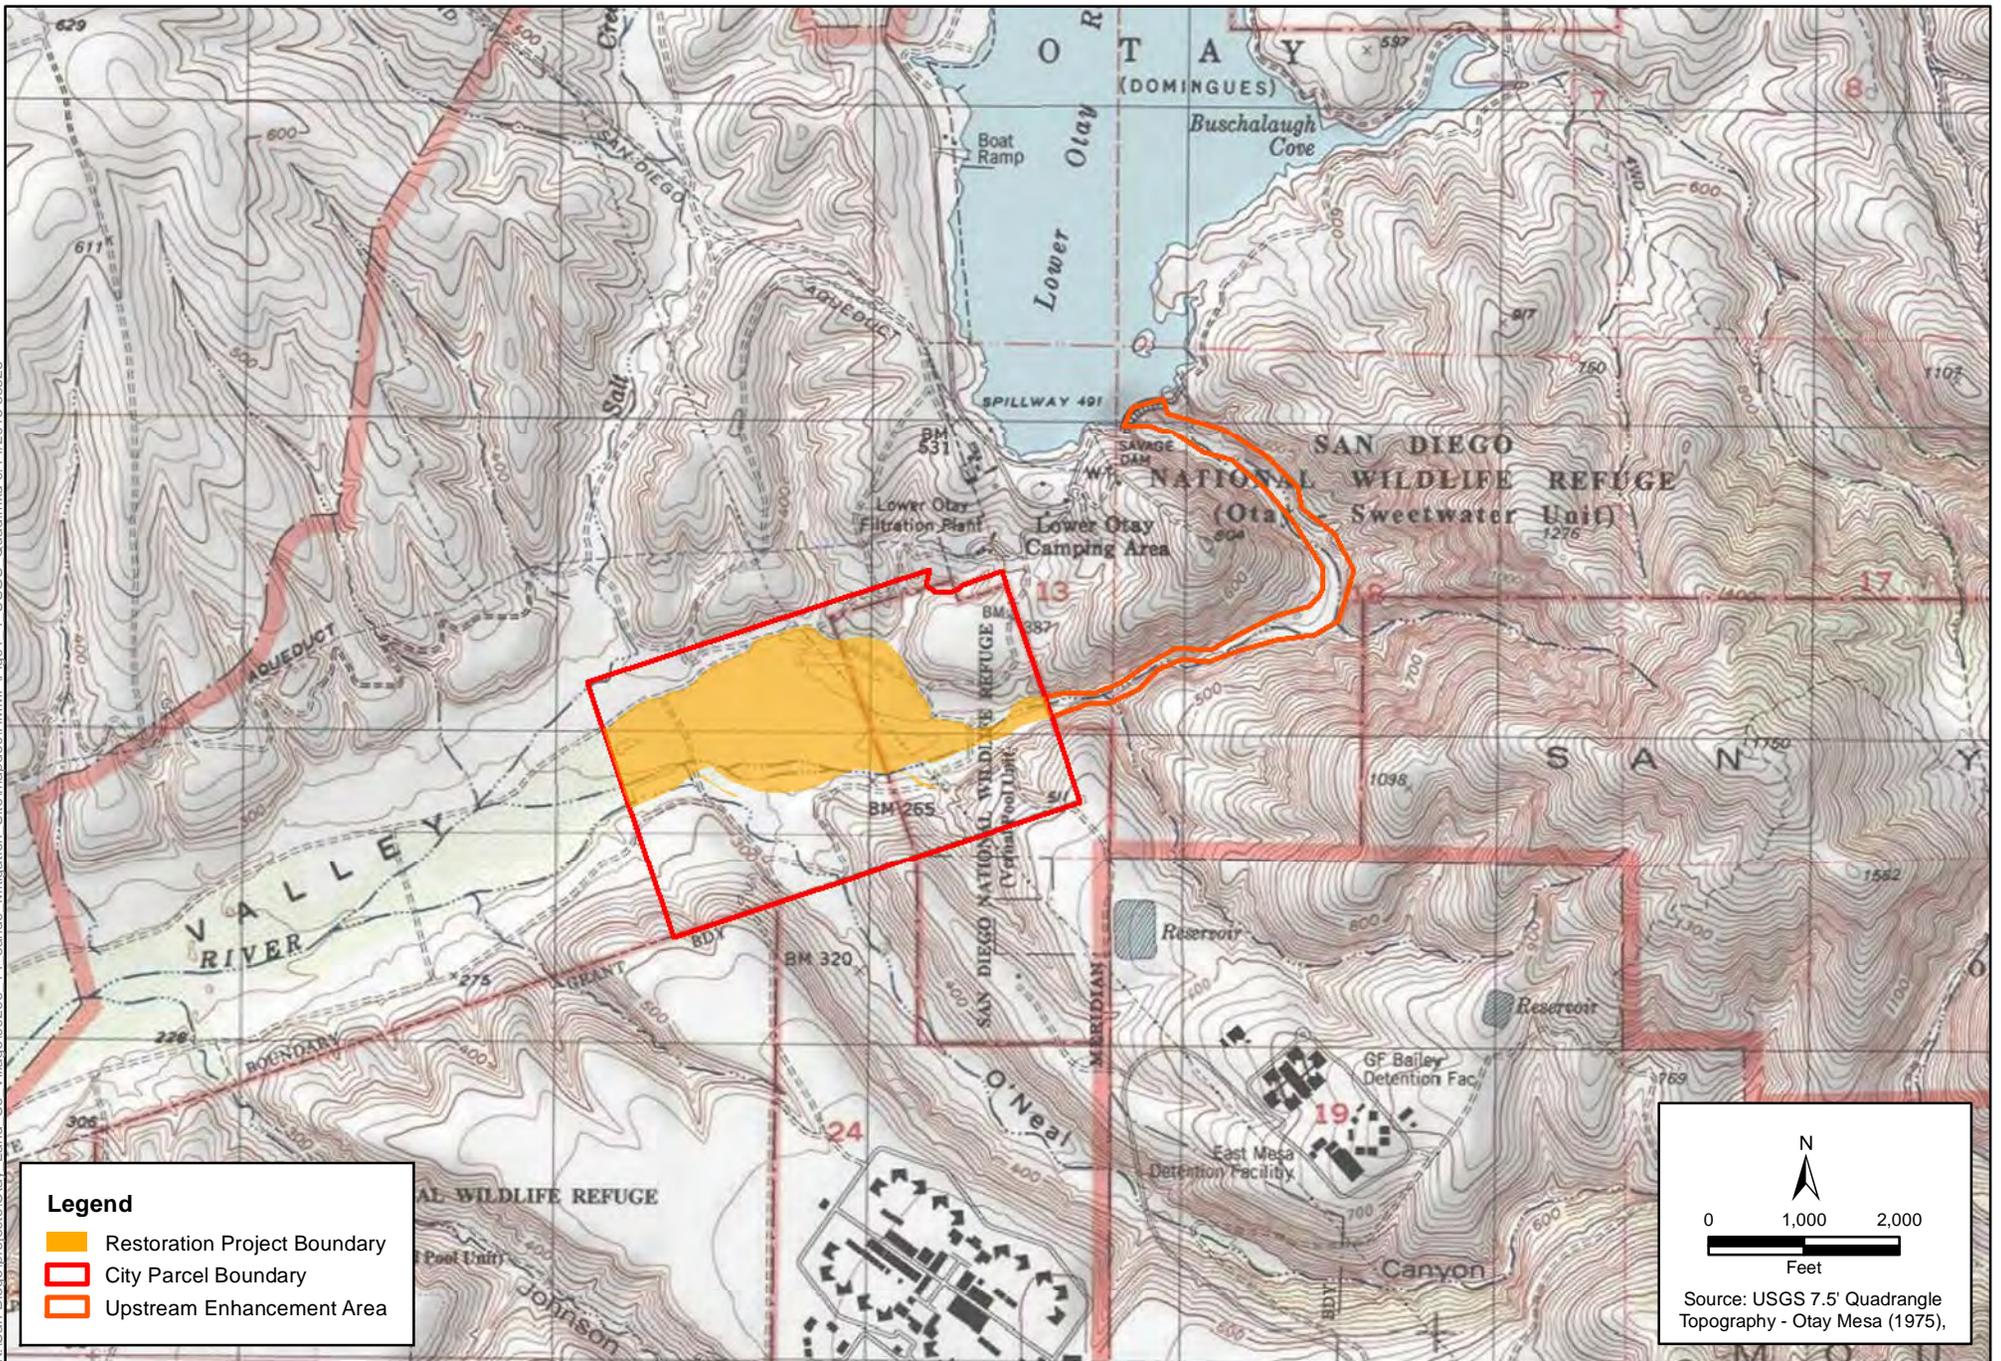
**Figure 1-4**  
**USGS Otay Mesa Quad Map**  
**Otay River Restoration Project**

The mitigation site is located within the Otay Mesa USGS 7.5-minute quadrangle map (Figure 1-4), in the Otay River Valley in southwestern San Diego County, California (Figure 1-2). The mitigation site occurs within the upper portion of the Lower Otay River Watershed, approximately 1 mile downstream of Savage Dam. As described above, the restoration project is divided into two discrete areas, the Mitigation Parcel (City of Chula Vista) and the Upstream Enhancement Area. The primary restoration project will be occurring in the Mitigation Parcel while a singular treatment season of invasive plant species will occur in the Upstream Enhancement Area.

- Enhance 6,000 feet of existing channel upstream of the main mitigation parcel, by treating approximately **2.74** acres of riparian habitat in the upstream Otay River mainstem immediately below the Savage Dam (Figure 1-4 and 2-1). The proposed enhancement areas are disturbed riparian areas whose natural habitat functions and services have been compromised and degraded due to the abundance of invasive trees and plants and the presence of Savage Dam. The proposed enhancement areas generally contain areas heavily infested and/or disturbed by tamarisk, giant reed (*Arundo donax*), pepper trees (*Schinus* spp.), eucalyptus (*Eucalyptus* spp.) and Canary Island date palms (*Phoenix canariensis*), as well as several other non-native species. This is a one-time effort to protect the restoration project downstream and will occur over the course of a single season. No subsequent work or maintenance is proposed in the Upstream Enhancement Area.

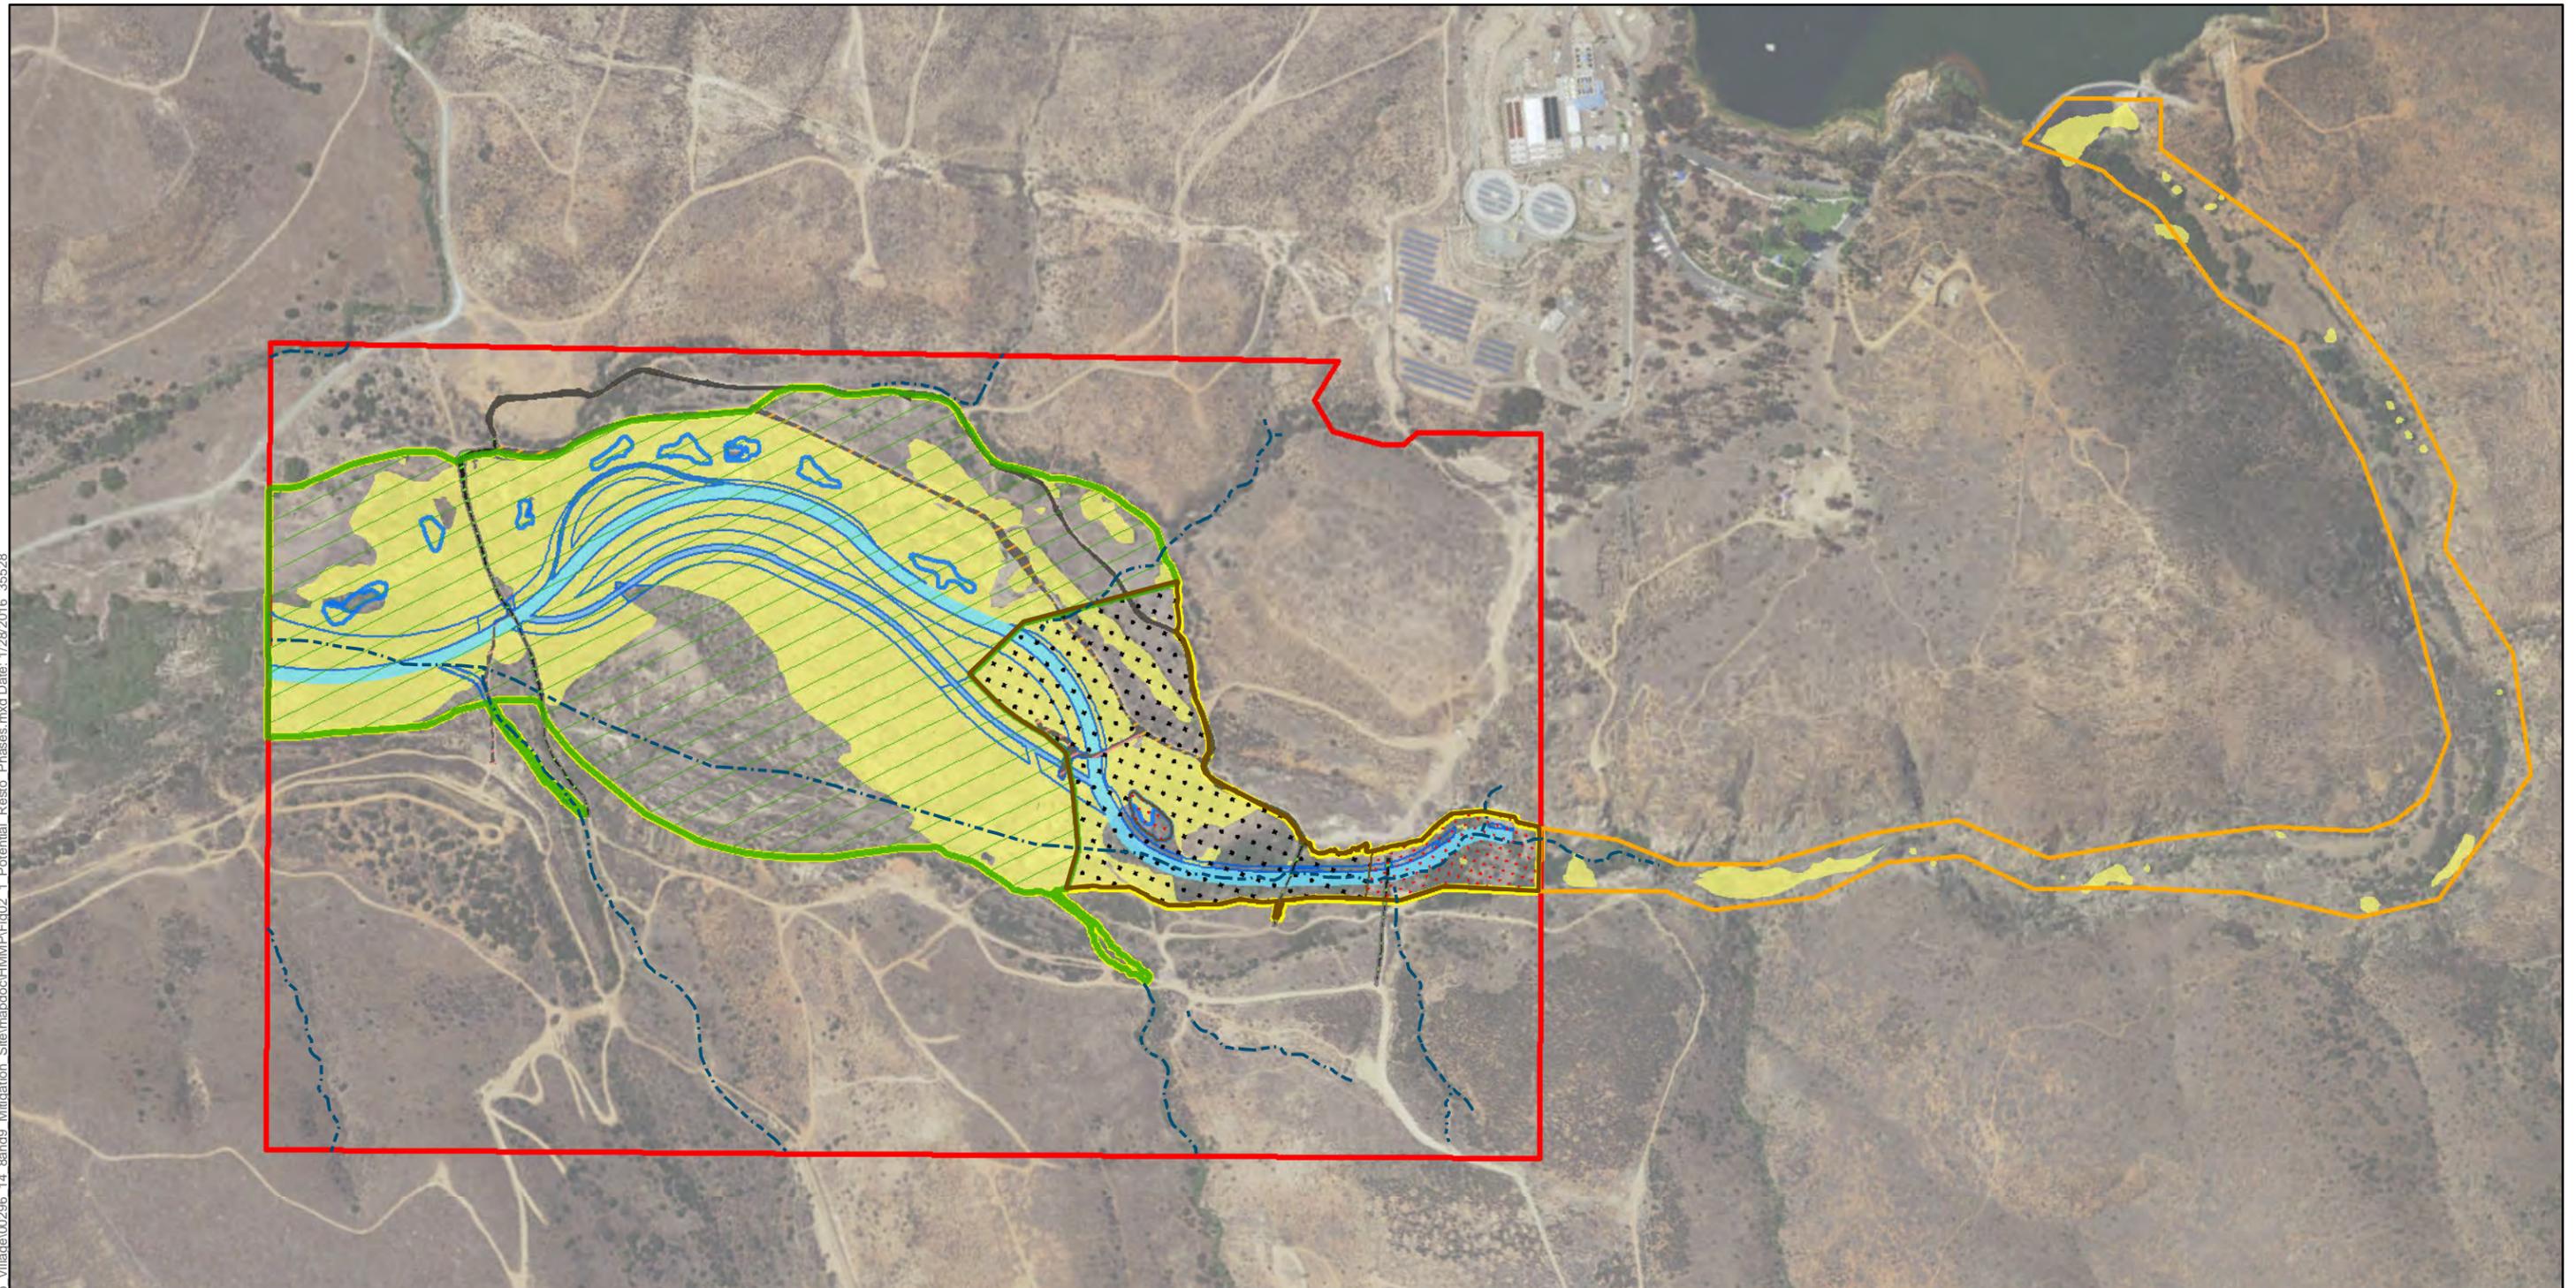
K:\San Diego\projects\Olay Land Co Village\00296\_14\_Band9\_Mitigation\_Site\mapdoc\HMMP\Fig02\_1\_Potential\_Resto\_Phases.mxd Date: 1/28/2016 3:55:28

- Re-establish approximately 13.5 acres of floodplain habitat including the mainstem by removing structures such as berms, rows of cobble piles and sediment and spoil piles that impede flow, and by removing and managing invasive species. This area within the plan boundary currently supports a large, nearly monotypic stand of tamarisk. The tamarisk and other non-native vegetation will be removed, the natural floodplain contours that were corrupted by mining activities will be recreated, and native plants will be installed following invasive plant removal and regrading.

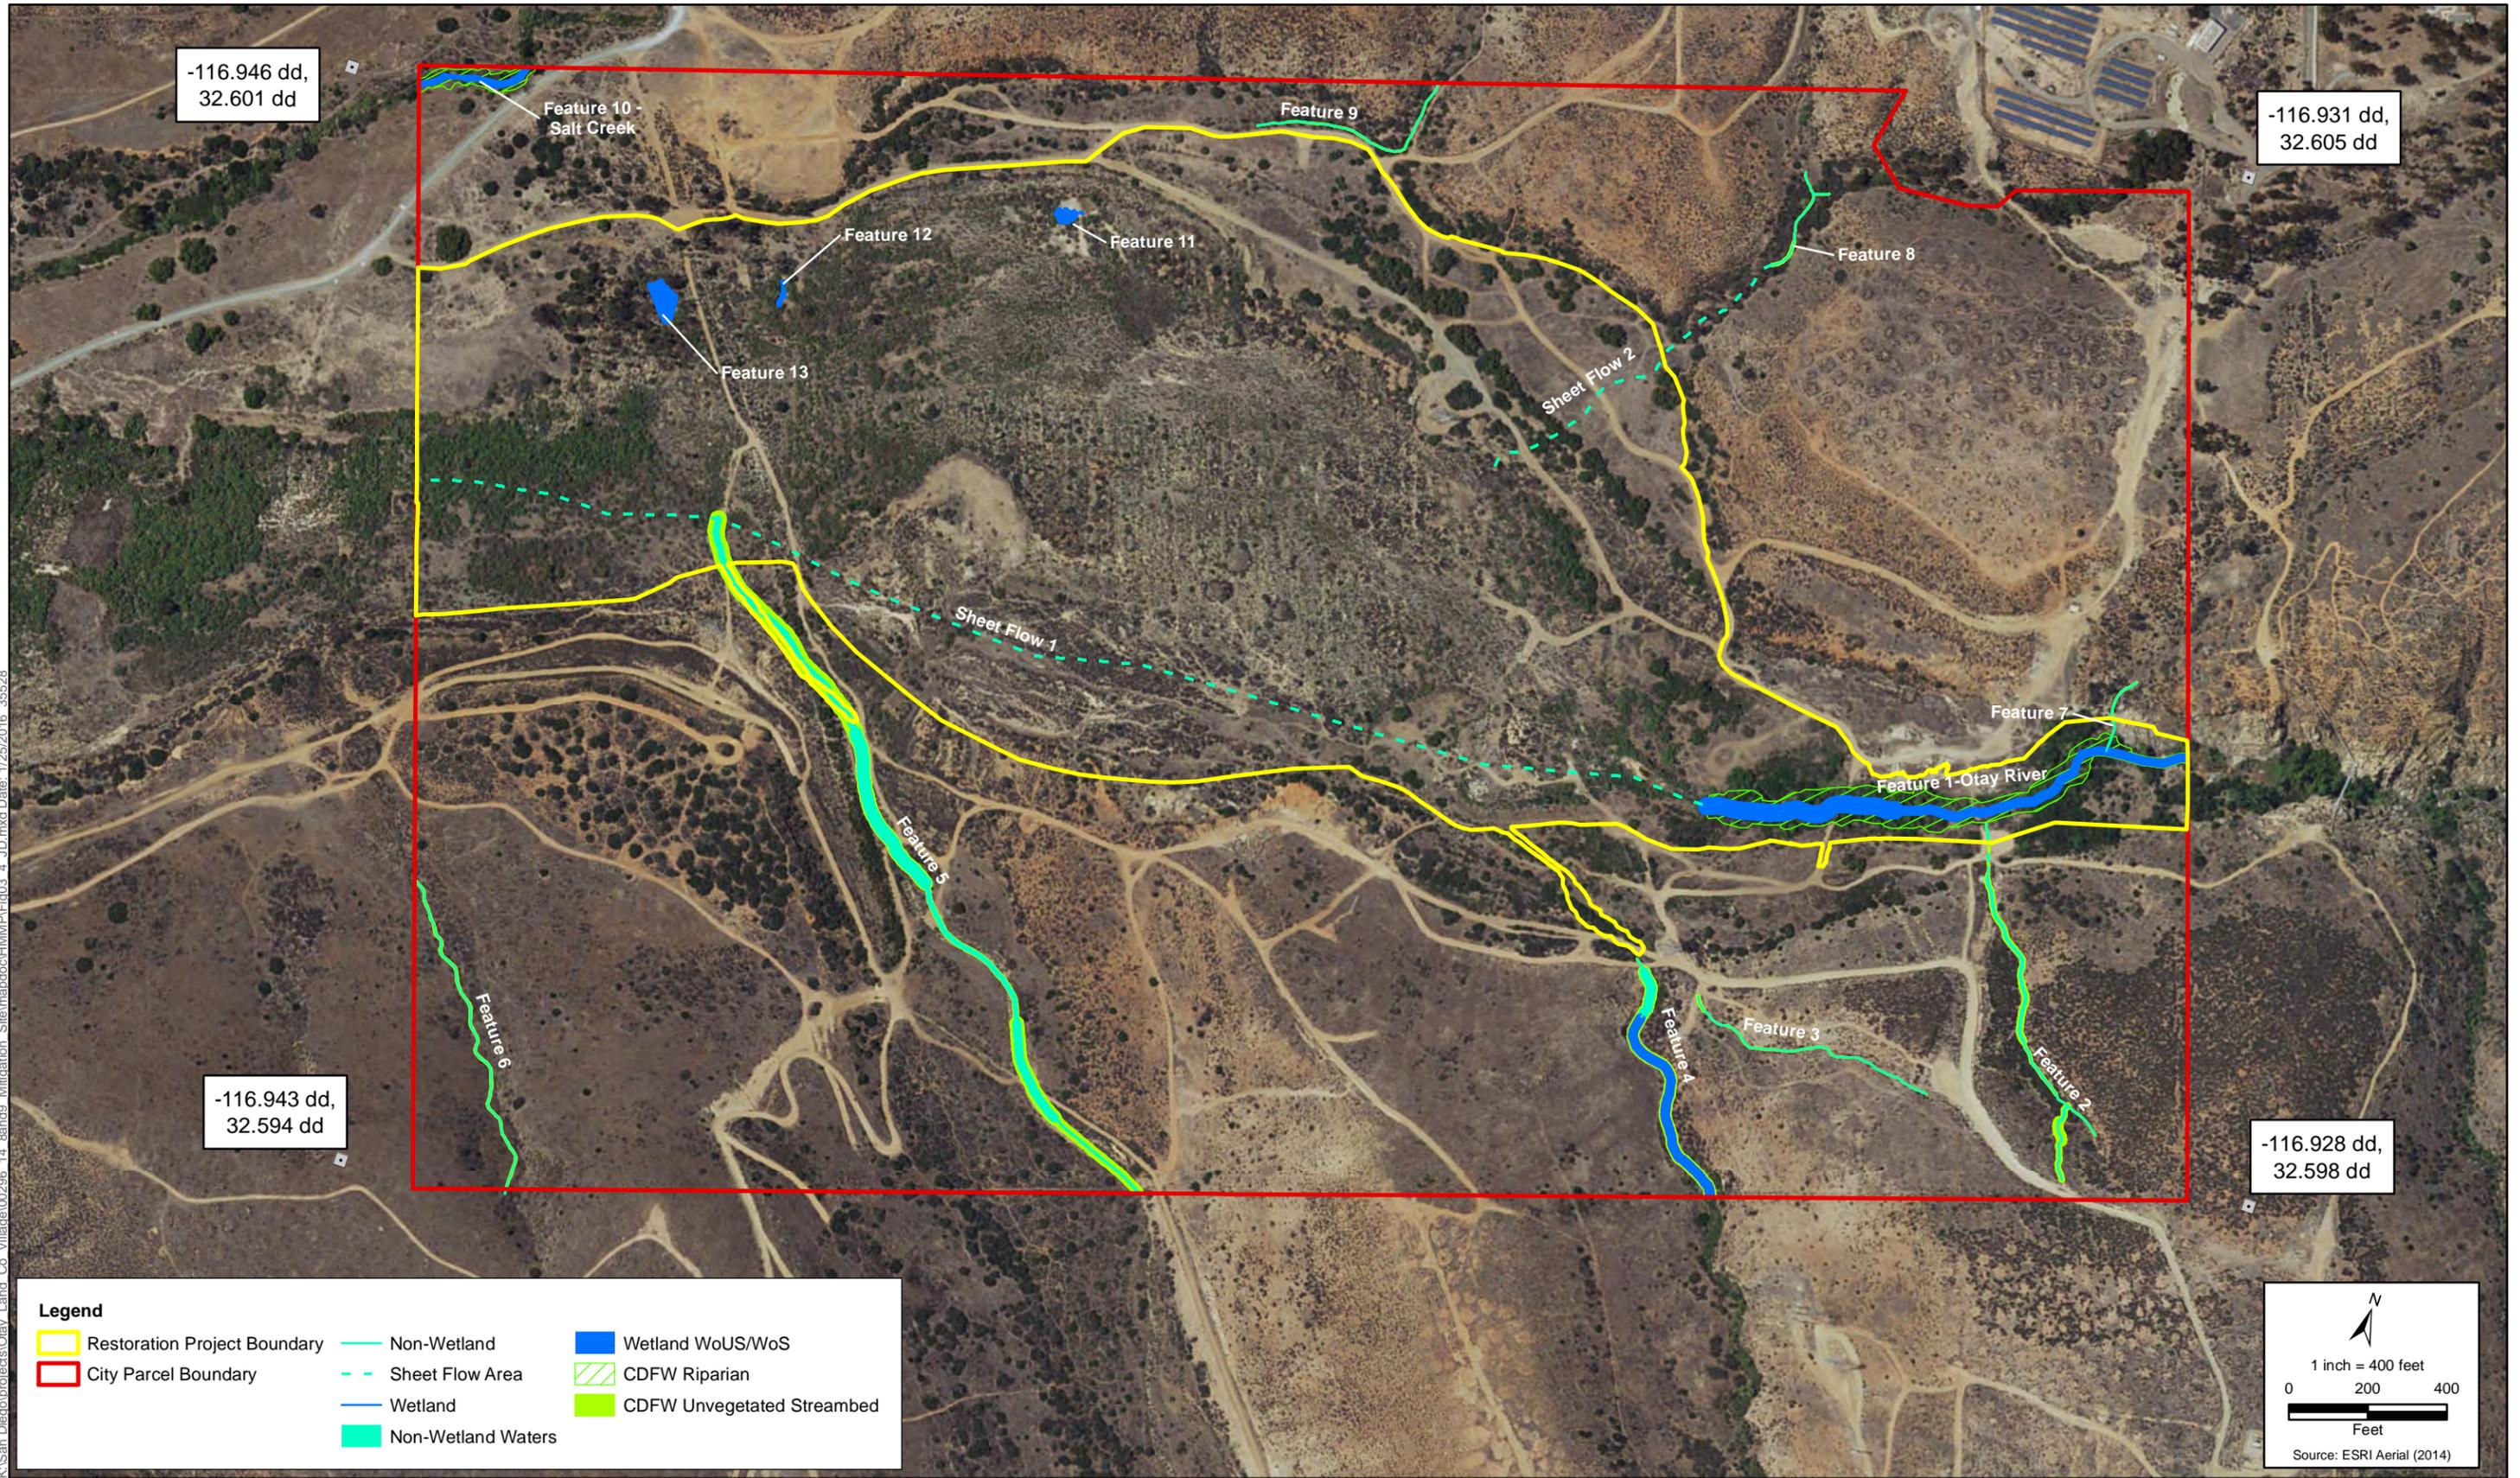
K:\San Diego\projects\Otay Land Co. Villane\00296-14\_Band9\_Mitigation\_Site\mapdoc\HMM\Fig03\_4\_JD.mxd Date: 1/25/2016 3:55:28

Although the site is degraded and the wetlands within the Mitigation parcel are limited as a result of past activities, there are still various functions provided by the existing wetlands and the adjacent upland areas (Figure 3-3). These functions may include but are not limited to groundwater recharge due to the extensive alluvium soils on site, wildlife movement opportunities due to the connectivity to adjacent open space and preserve land, and nesting and foraging habitat associated with the existing vegetation. The area provides foraging and limited water sources for a variety of mammal, avian, reptile and amphibian species, including sensitive species. Coastal California gnatcatcher is present within coastal sage scrub communities on site, and the area has potential to support the federally listed as endangered Quino checkerspot butterfly. Southern willow scrub in the area supports the federally and state-listed as endangered least Bell’s vireo and provides suitable nesting habitat for a variety of bird species protected by the MBTA. The dry conditions in the floodplain have allowed for the establishment of several groves of the Tecate cypress. A major population of this species was severely affected by the Otay Fire of 2003; this floodplain population may be an important source for seed for restoration on Otay Mountain and other areas.

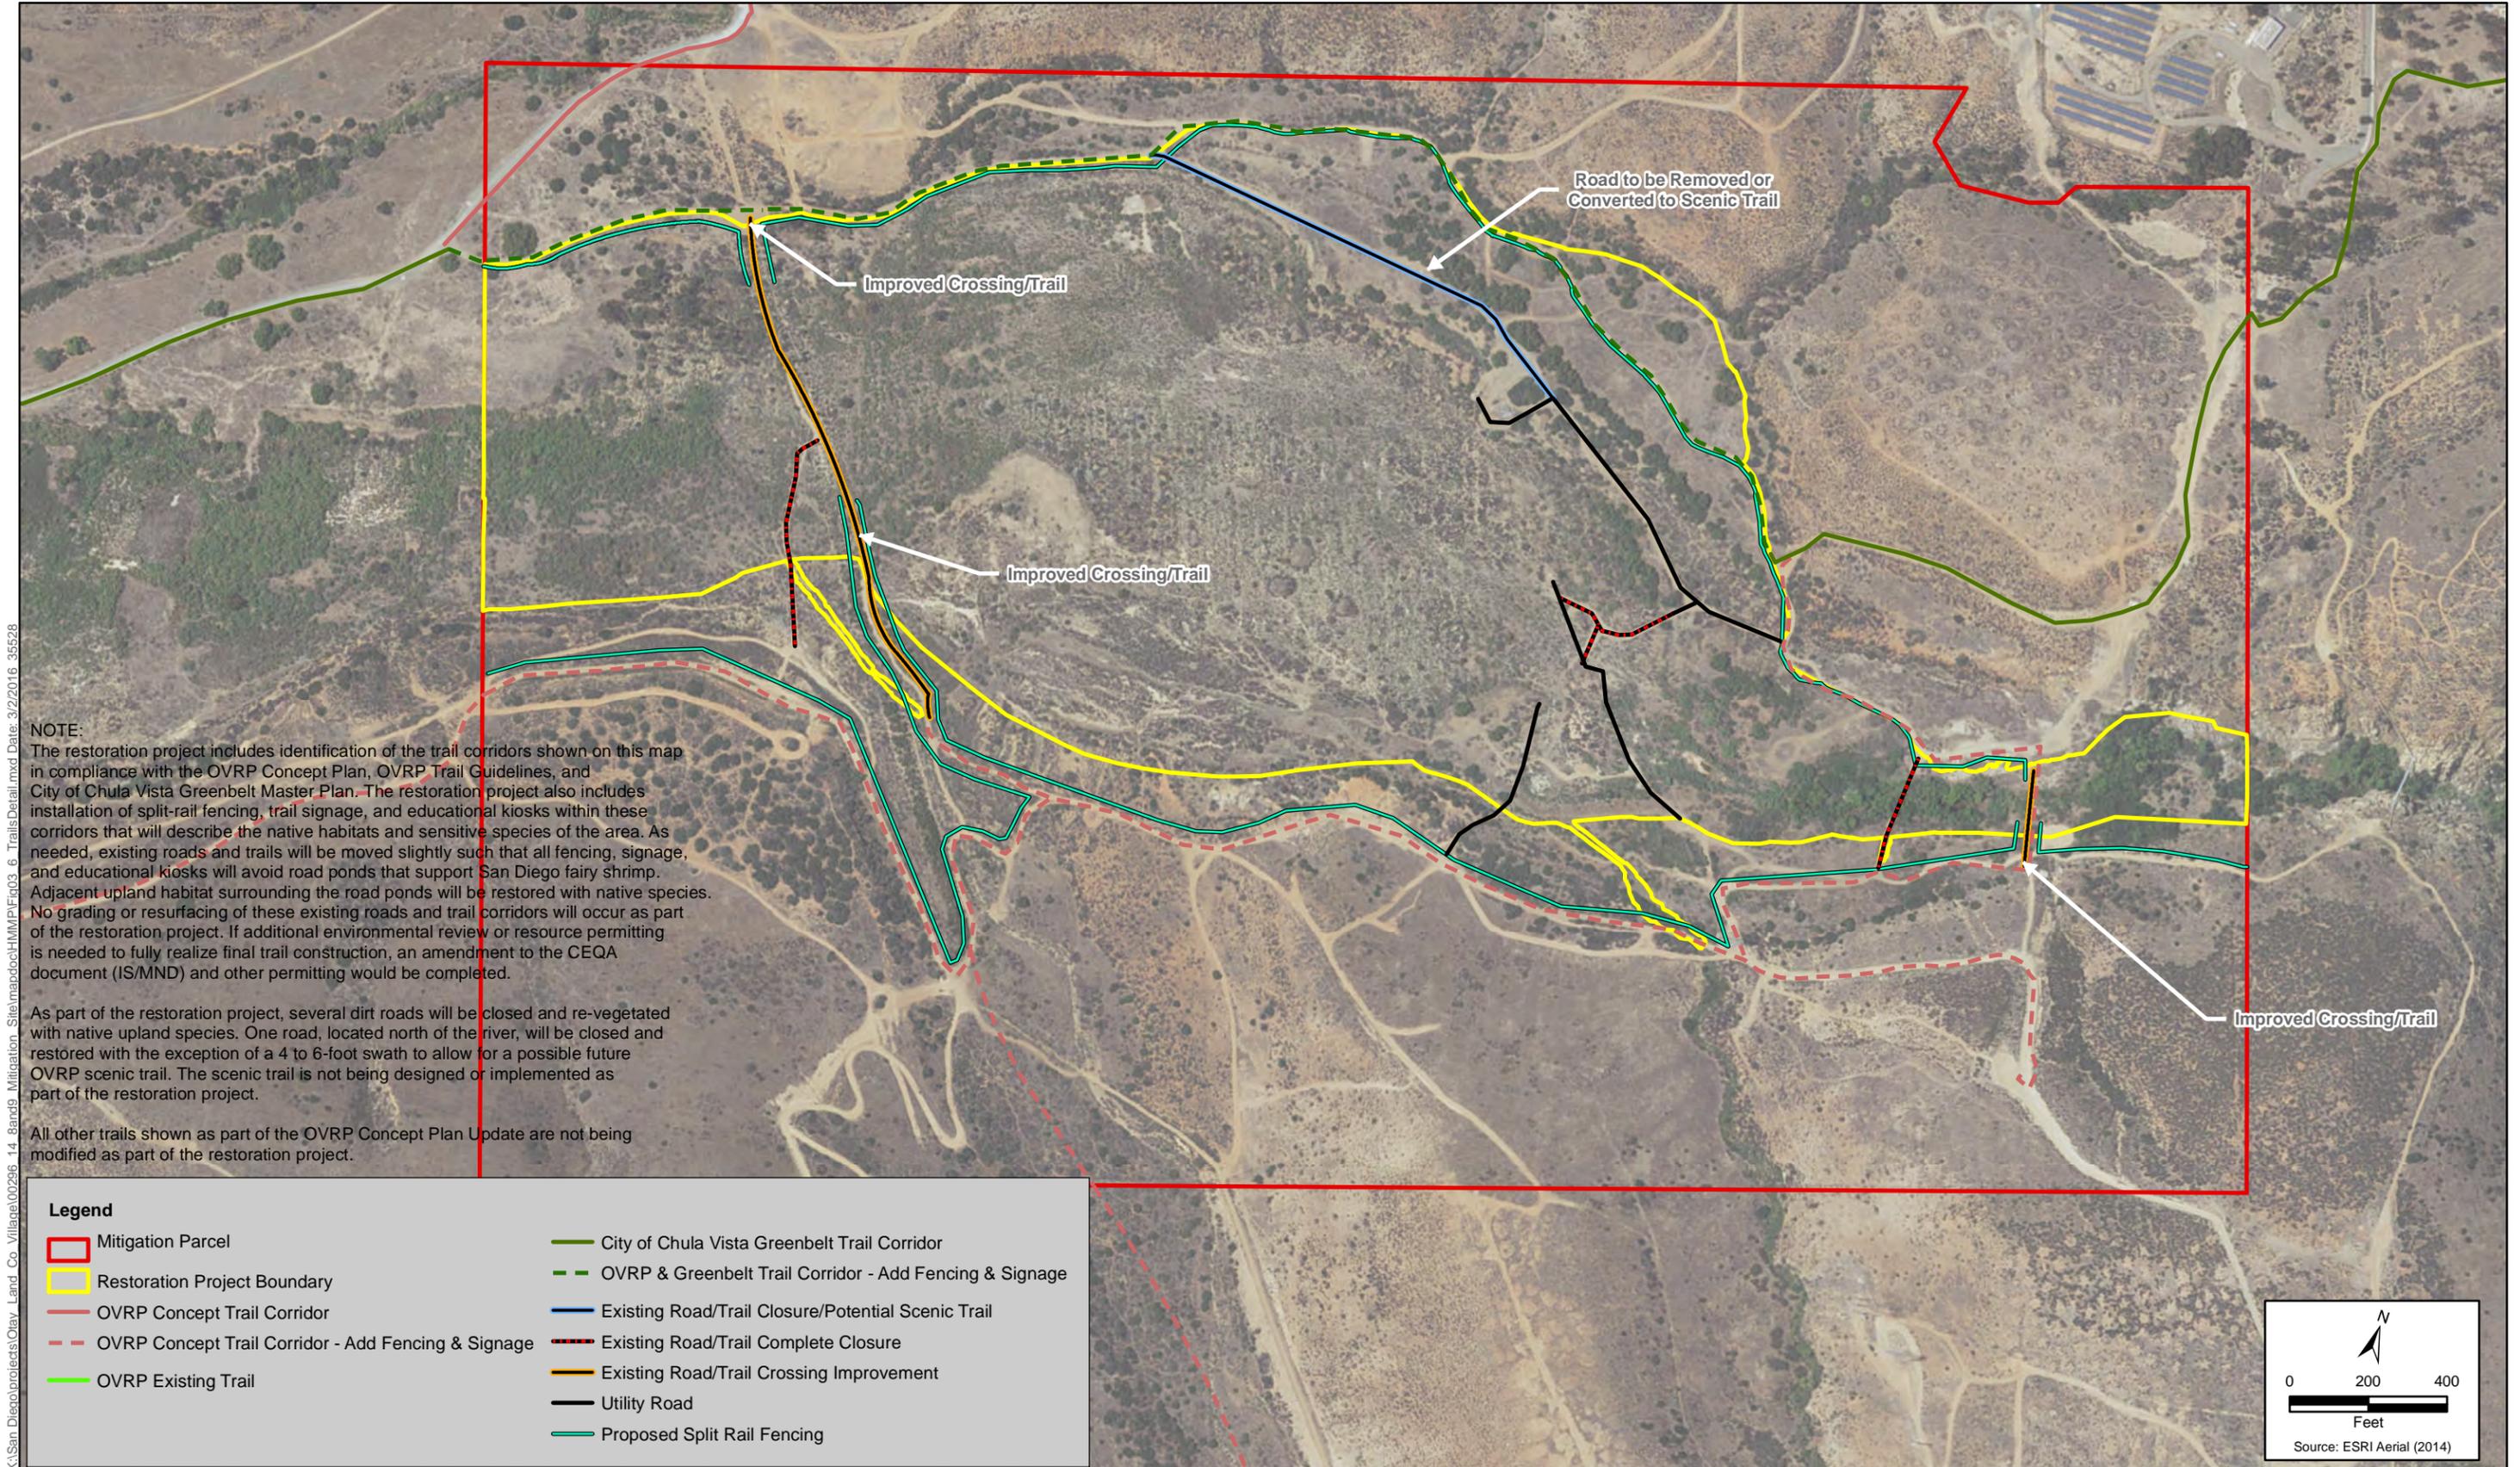
K:\San Diego\projects\Otay Land Co Villages\00296 14 Band9 Mitigation\_Site\mapdoc\HM\PF\Fig03\_6 TrailsDetail.mxd Date: 3/2/2016 3:55:28

Figures 3-5 and 3-6 identify the designated Greenbelt Master Plan trail and the OVRP trails, and indicate where these corridors are located within the project site. The figures also indicate which trails (i.e., existing roads) would receive trail improvements such as split-rail fencing, signage, and educational kiosks and which trails would be closed. Improvements associated with the portion of the trail identified within the City of Chula Vista's Greenbelt Master Plan would be consistent with the guidelines of that plan and would be installed on existing roads or disturbed habitat that cross and meander in and out of and along the restoration site's northern boundary. Per the Master Plan, the restoration project would identify a 14-foot-wide trail location for the Greenbelt Trail to accommodate multiple uses. Improvements associated with trails identified under the OVRP Concept Plan would be consistent with the guidelines of that plan and would be installed on existing roads that cut through the restoration site and also meander south and east across the property. The restoration project would allow for trail corridors consistent with Type A, B, and C that range between 4 and 8 feet in width. All road and trail improvements would avoid existing road ponds that support San Diego fairy shrimp by moving the alignment as needed, and the adjacent upland area would be restored with native species.

Many of these roads are identified as future multi-use trails as part of the OVRP Concept Plan and the City Greenbelt Master Plan (Figures 3-5 and 3-6). Altogether there is approximately 6,500 linear feet of the future Greenbelt Master Plan trail and approximately 10,200 linear feet of OVRP trails that occur on the property. This area is a travel route for migrants entering the U.S. from Mexico; there is regular immigrant foot traffic through the river valley and a corresponding significant use of the area by Border Patrol agents using off-road vehicles. The persistent use by these large vehicles has resulted in large berms perpendicular to the flow of water at the upstream crossings, which

Figures 3-5 and 3-6 show the location of all existing and future trails as well as the various locations for project improvements. All improvements associated with the portion of the trail identified within the City of Chula Vista's Greenbelt Master Plan or the OVRP Concept Plan would be consistent with the guidelines of that plan and would be installed on existing roads that that cross and meander in and out of and along the restoration site.
